Observations on Morphological Changes Produced by the Impact of the February 27, 2010 Tsunami along the Coastline of VI-VII Regions

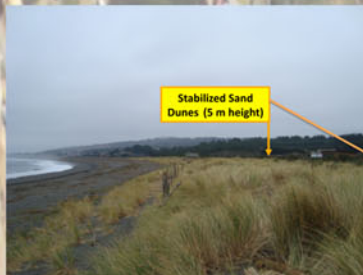
The Estero Nilahue is an example of coastal lagoon formed by the dominant action of energetic wave climates. Most of the time, the ephemeral water course, that originates from stormwater runoff over a relatively small coastal watershed, is not able to overcome the influence of littoral currents, hence sediments carried by waves end by completely closing the river mouth (Figure 1). These morphological features often offer natural protection to coastal settlements from wave attack but can be problematic when river flood occurs. After the February 27 earthquake, the sand bar that prevented the estero Nilahue to reach the sea disappeared under the action of tsunami waves that hit the shoreline (Figure 1).

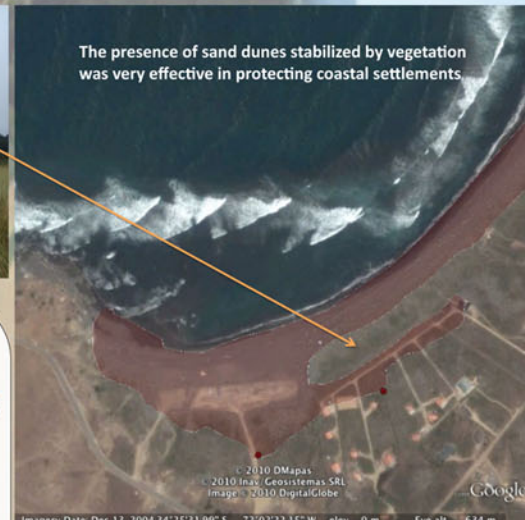
Figure 6 : Estimated inundated area by the February 27, 2010 tsunami at Punta de Lobos (VI Region)

At several places, such as Punta de Lobos (VI Region), sand dunes stabilized by vegetation prevented a direct hit of the tsunami offering an effective protection (Figure 6)

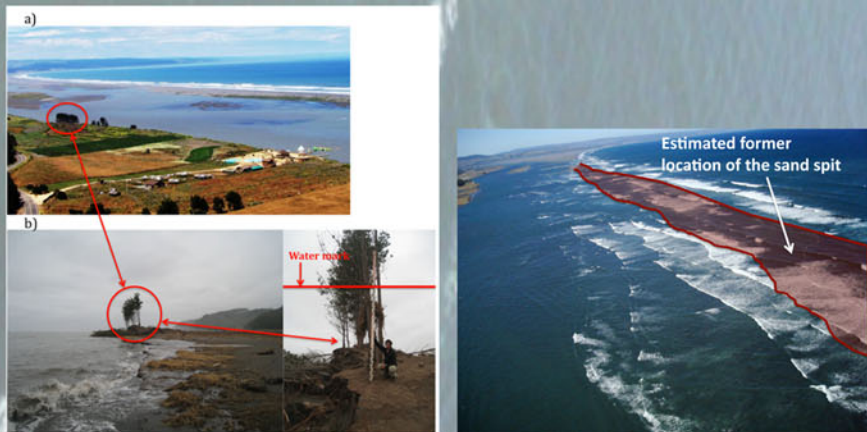
Figure 3 : The Mataquito river inlet before (a) and after (b) the February 27, 2010 earthquake and tsunami (Photo in the upper panel courtesy of Andrea Allamand)

Figure 4 : Aerial photography of the Mataquito river inlet taken on April 19, 2010 (Photo courtesy of Arauco S.A., Nature Fims)

At the river mouth, located at la Pesca (VII Region), the wave-current interaction pattern is responsible for shaping a sand spit oriented to the north. The river discharge is forced to run almost parallel to the coastline over nearly 10km (Figure 3). Main sediment source to the sand spit is most likely associated to the Mataquito river itself but also to the Maule river, located 50km south. The spit height was 2-3m height, with a mean width of 130-150m and 9-10km long before the arrival of the 27 February 2010 tsunami. The spit was totally washed out after the shock, under the combined effect of the earthquake (subsidence) and the Tsunami (sediment transport). Thus, nearly 3 millions cubic meters lie now under water (Figures 4 and 5).

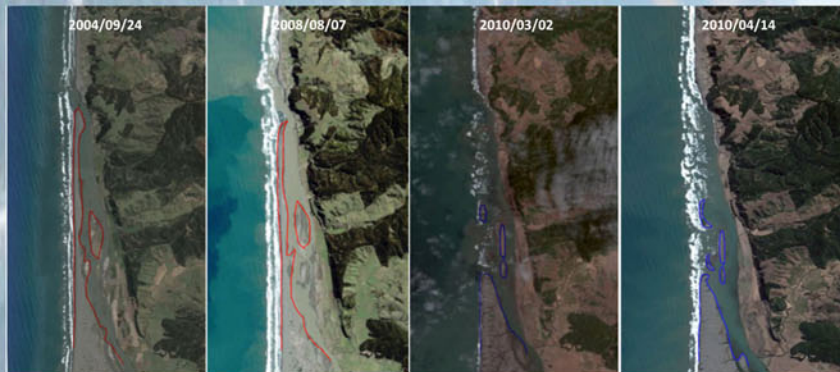
Figure 5 : Geoeye Satellite images of the Mataquito river mouth evidencing the spectacular morphological change produced by the February 27, 2010 earthquake and tsunami
